CASE STUDY
Fire at Formosa Plastics Corporation

Incident Description

This case study examines a hydrocarbon release and subsequent fire and explosions that occurred in the Olefins II unit at the Formosa Plastics Corporation, USA, (Formosa) Point Comfort, TX, complex.¹

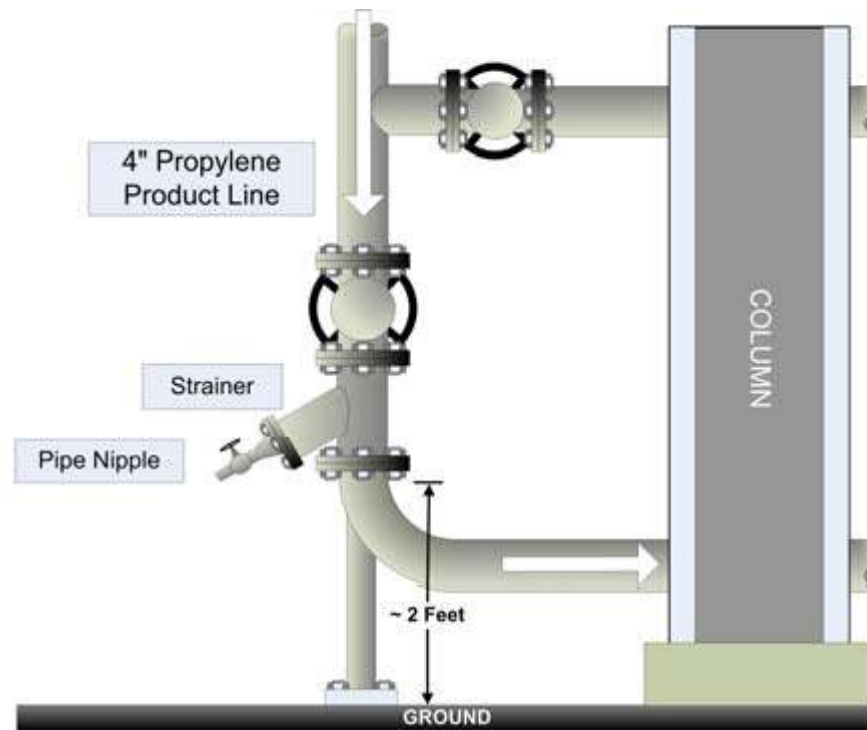
Pipe and valve arrangement : No Vehicle Impact Protection

In Process Hazard Analysis and in PSSR (Pre Start Up Safety Review) Vehicle Impact Protection and Administrative control was considered for Fire Protection Equipment but it was not considered for specific process equipments.

During the facility siting analysis, the hazard analysis team discussed what might occur if a vehicle (e.g., fork truck, crane, man lift) impacted process piping. While the consequences of a truck impact were judged as “severe,” the frequency of occurrence was judged very low (i.e., not occurring within 20 years), resulting in a low overall risk rank. Because of the low risk ranking, the team considered existing administrative safeguards adequate and did not recommend additional traffic protection.

When performing a hazard analysis, facility siting analysis, or pre-startup safety review, vehicle impact and remote isolation of catastrophic releases should be investigated.

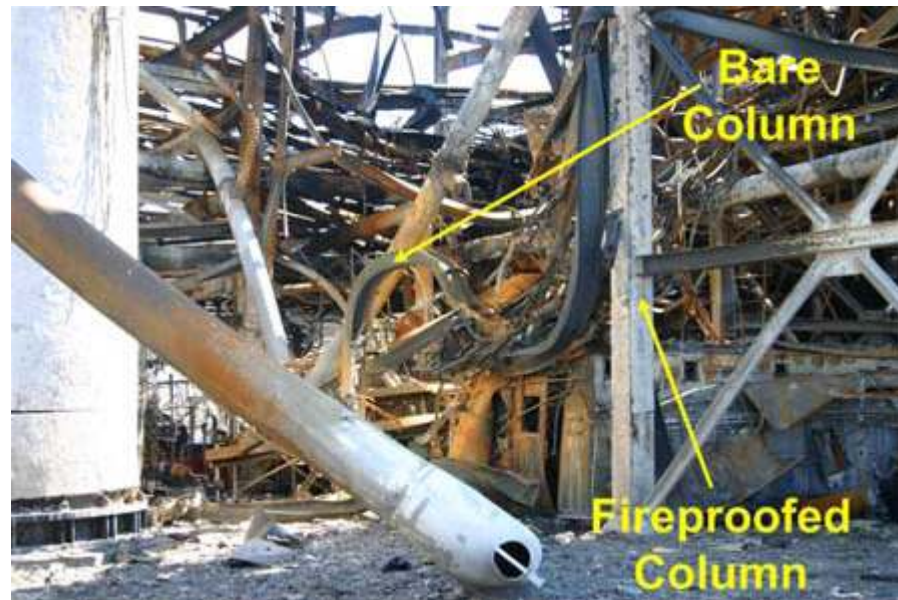
Fireproofed and bare steel support columns.

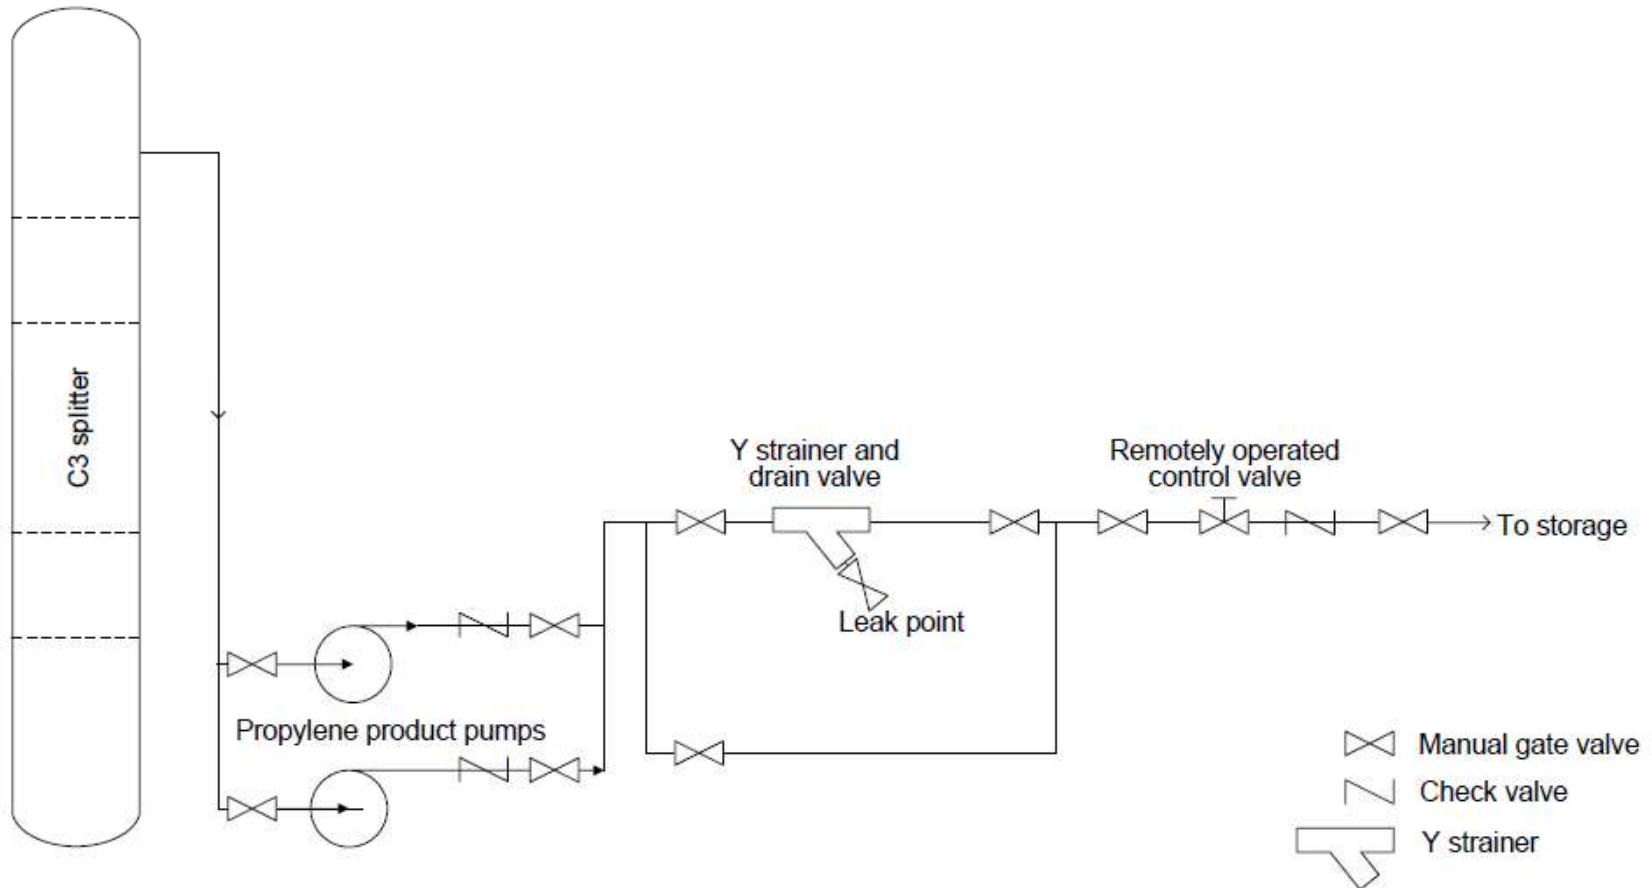
Propylene Product Flow
